Cleaning of Diesel Particle Filters

BENCH TESTS DPF CLEANING

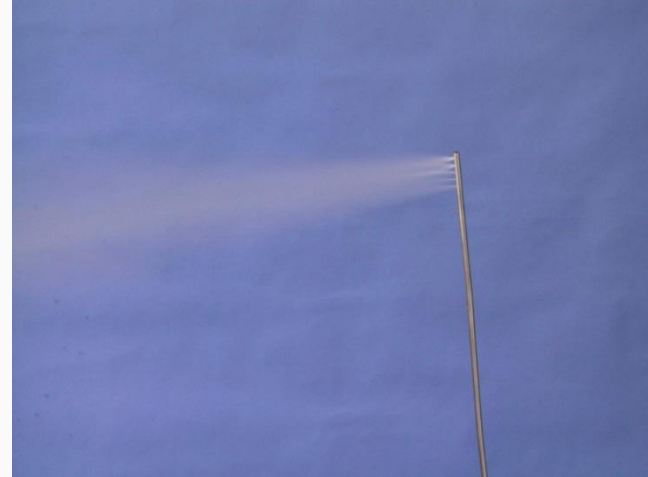
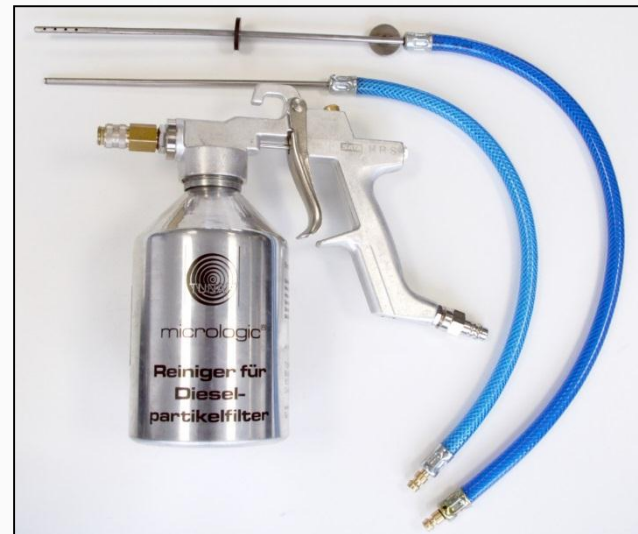
- By a mechanical-chemical cleaning, regeneration of the filter is possible again.
- The particle filter does not need to be removed.
- Uses of a pressure cup spray gun with a special probe.

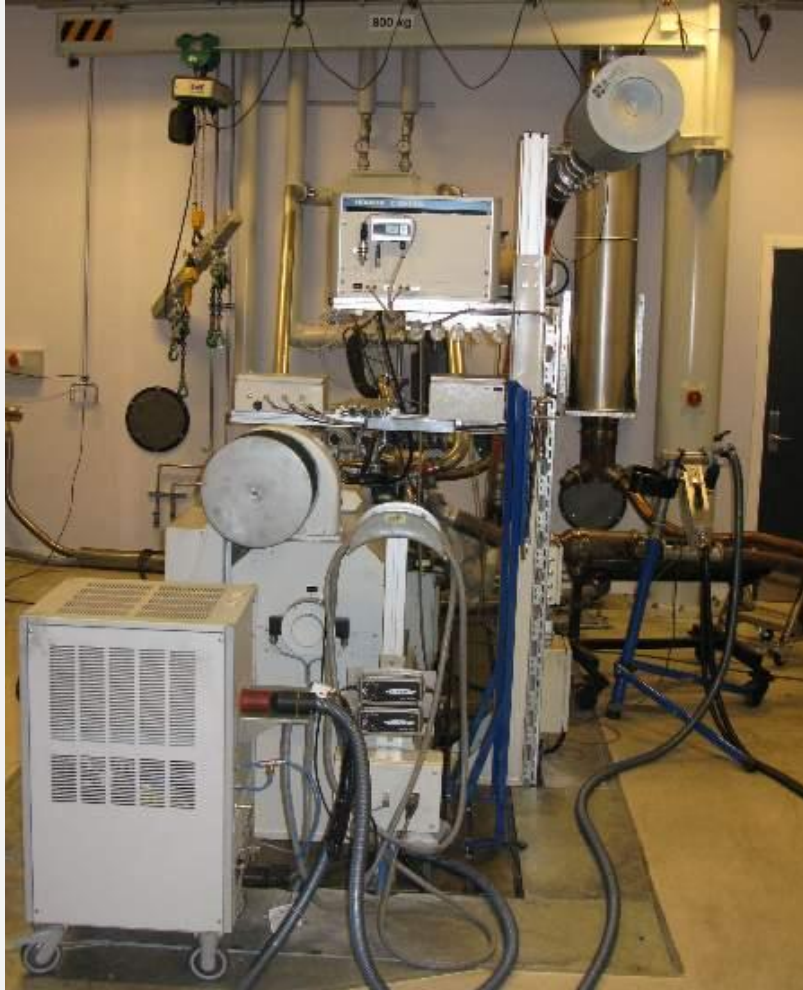
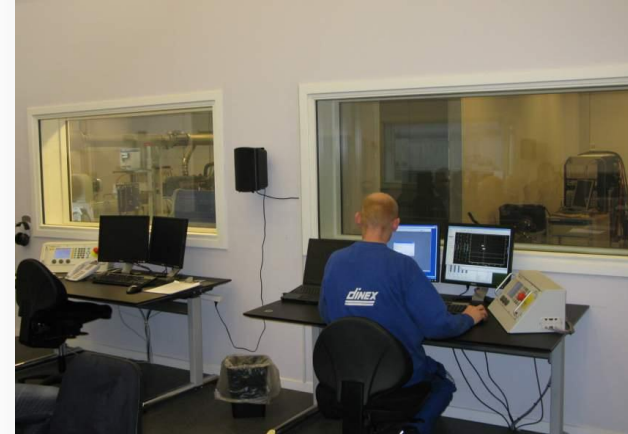
ENGINE TEST RIG

Engine: VM R425 2,5 l 100 kW

Particle Filter: DINEX X25
Siliziumkarbid $\varnothing 5,66'' \times 8''$

Coating: Platinium

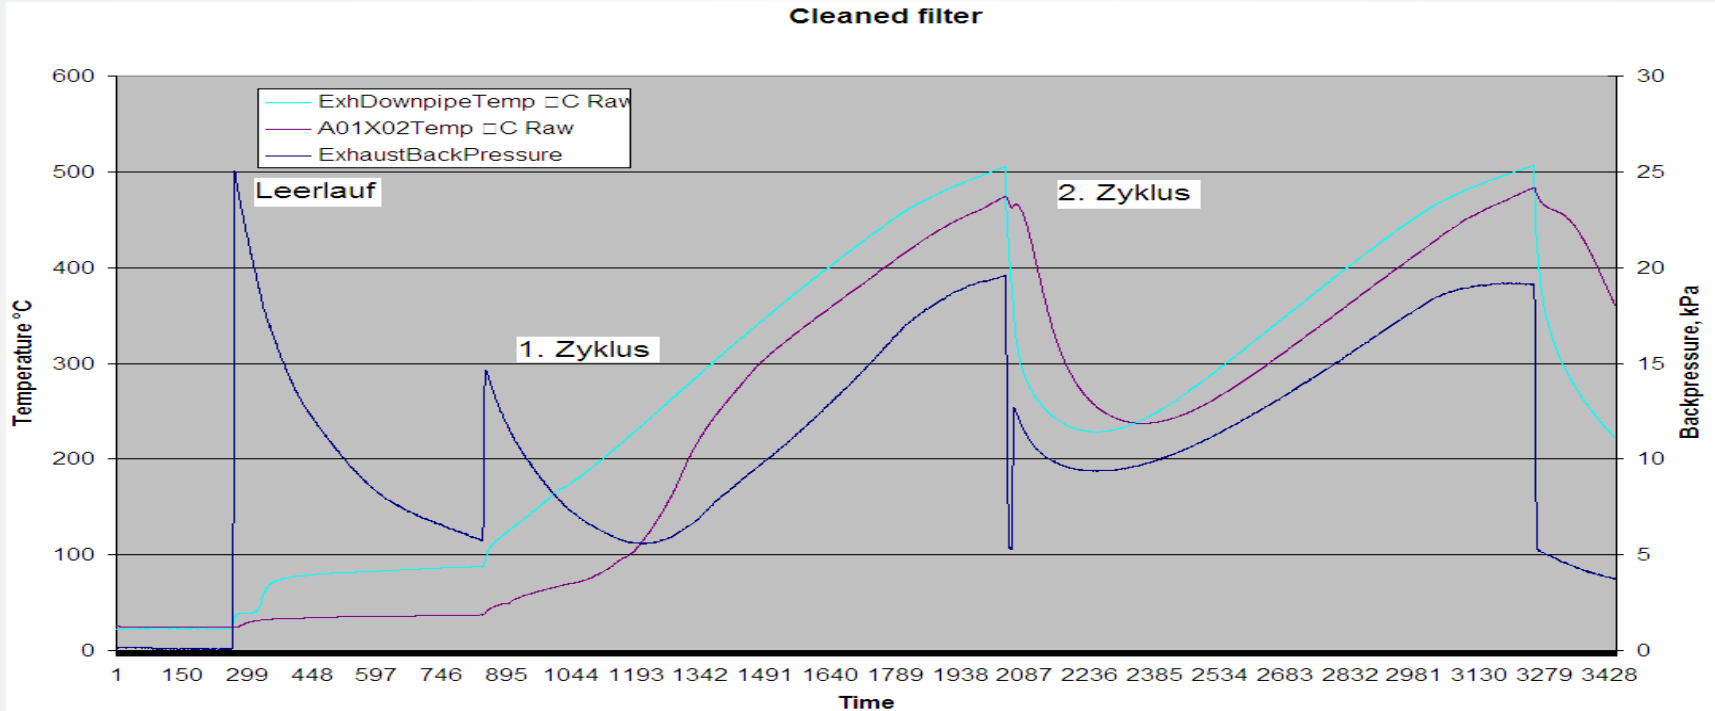
REGENERATION OF A TREATED FILTER

BP at start ideling: 25,0 kPa
 BP after ideling: 5,7 kPa (20,0 kPa)
 BP at maximum load: 19,5 kPa (37,2 kPa)
 BP at end of test: 4,0 kPa (10,6 kPa)
 BP fresh filter: 3,9 kPa

Temperature after filter distinctive lower than before filter
 Maximum temperature after filter: 475°C (547°C)
 Maximum temperature before filter : 504°C (549°C)

Werte in Klammern sind Werte vor Reinigung.

- At engine start the exhaust backpressure rises briefly to about 20kPa. This is due to the fact that there is still a amount of cleaning liquid in the filter, which is pressed with the exhaust gas through the filter.
- Thereafter, the exhaust backpressure drops at idle to 5,7kPa and at full load on 19,5kPa. This is a proof that a large amount of soot was flushed through the cleaning. The comparison value of the untreated filter was after regeneration 20kPa at idle and at full load 37,2kPa.
- The exhaust backpressure at test end after regeneration was 4kPa, which corresponds to a new filter. In comparison, the value for a only regenerated filter was 10,6kPa.

- The temperatures are generally at a much lower level between 504°C before filter and 475°C after the filter. An untreated filter reaches in comparison both before and after the filter temperatures around 550°C.
- Striking is also that the temperature before filter never exceeds the temperature after the filter. Rather, it is always a difference of at least 25°C to see.
- The rise of the temperature after filter is due to an exothermic reaction in the oxidation of the soot during regeneration. A lower temperature rise, therefore means that already much of the soot has been rinsed during the cleaning.

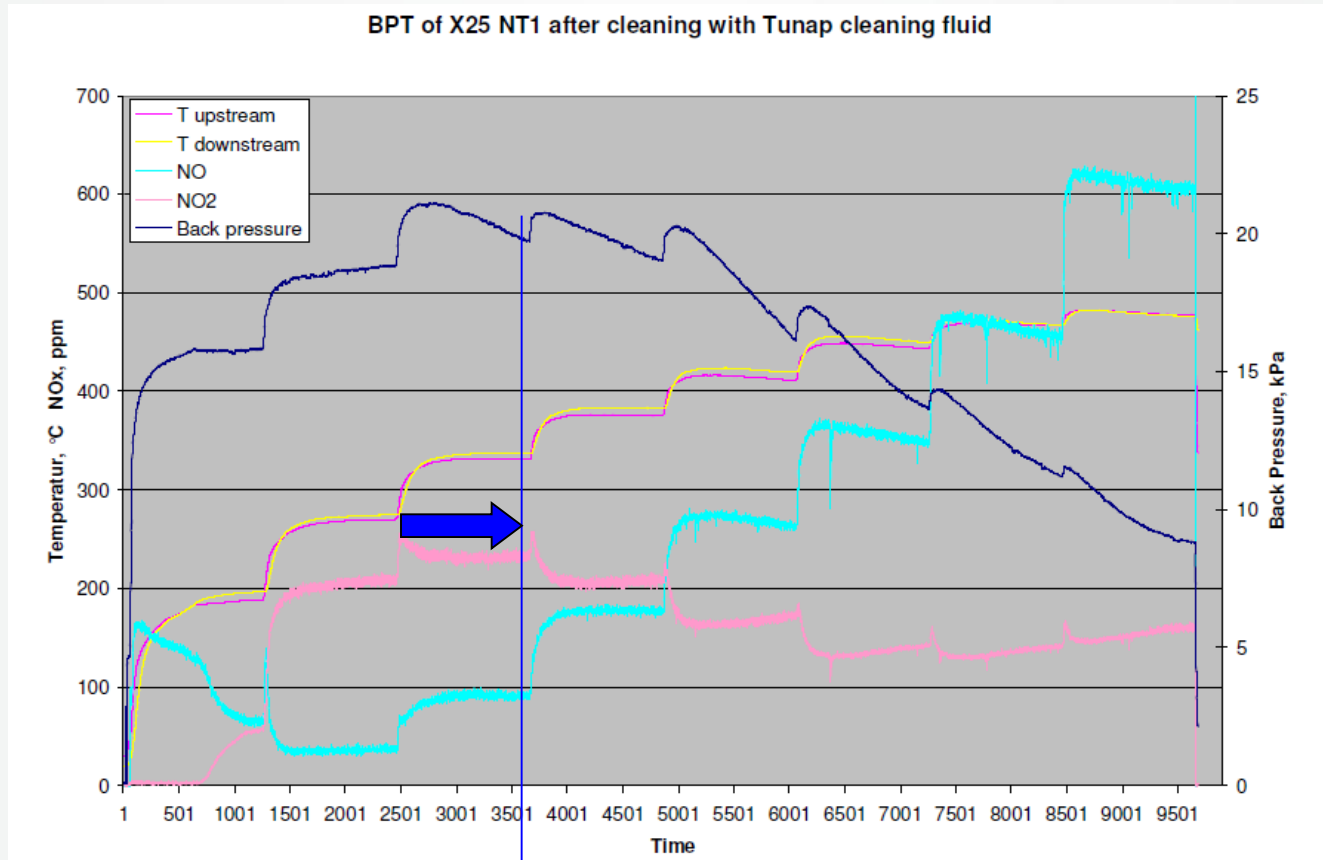
DETERMINATION OF THE BALANCE POINT

The balance point temperature of the treated filter is 320°C, which is within normal for Dines X25 coated filters.

The balance point is the point where sampled particles are as much as the oxidised particles. This is the point with the highest backpressure before the backpressure curve drops down.

- The balance point of the cleaned filter is exactly the same as of an uncleaned filter.
- It can be concluded that the catalytic coating of the purified filter works the same way that a crude filter.
- In case of a damage to the coating the balance point would be higher , and there would higher temperatures required for combustion of the soot.
