Chemical cleaning of Diesel Particle Filters

BENCH TESTS – EFFICIENCY + TEMPERATURE MONITORING

VERT Retrofit „Project Megacities“

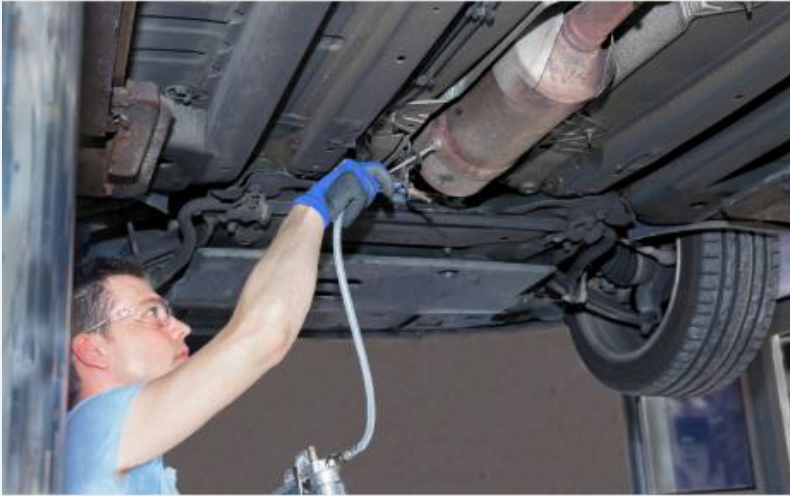
- Mechanical-chemical cleaning
- Easy application
- The particle filter does not need to be removed.

- Pressure cup spray gun with a special probe
- Cleaner + flushing concentrate

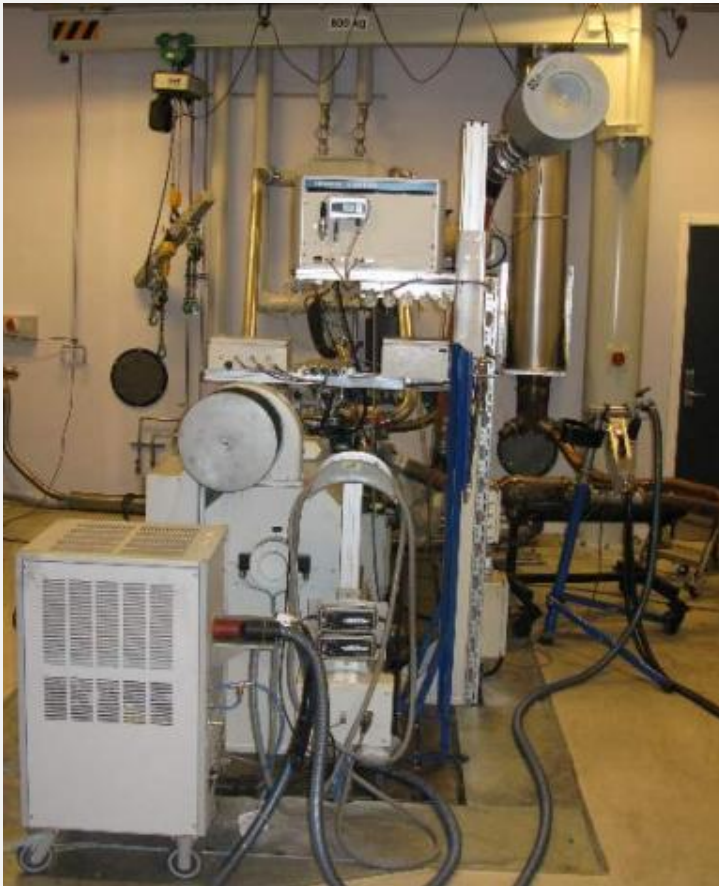
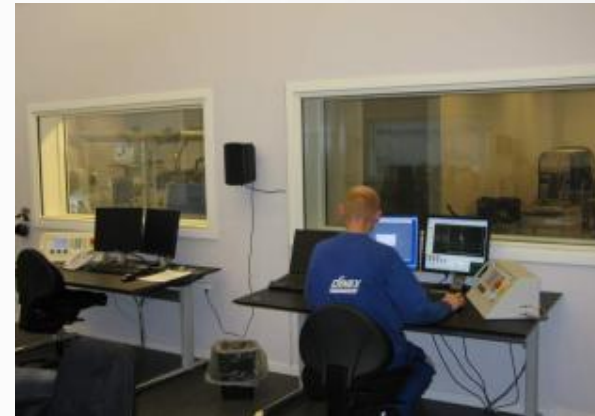
Engine: VM R425 2,5 | 100 kW

Particle Filter: DINEX X25 Siliciumcarbide
ø5,66" x 8"

Coating: Platinum

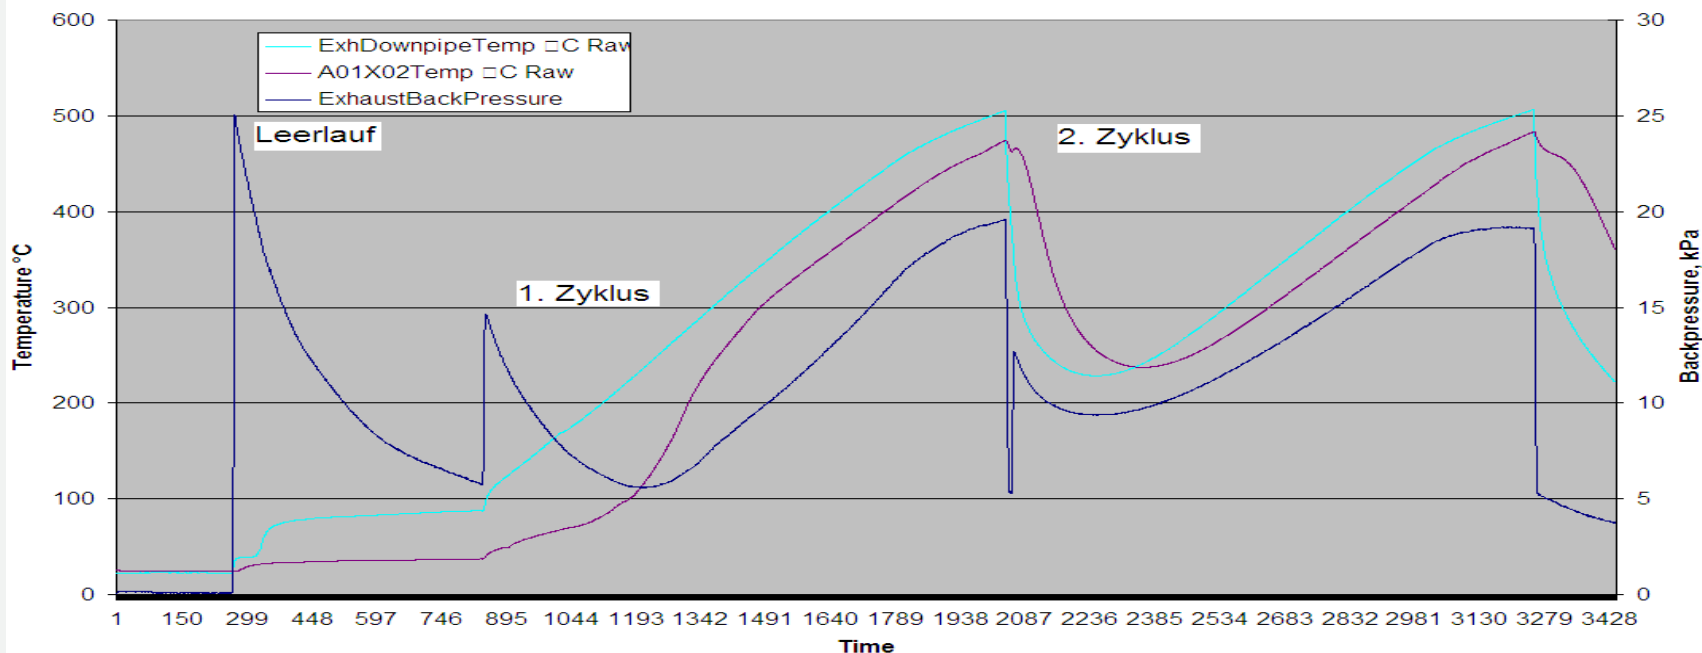
Regeneration treated filter

BP at start ideling: 25,0 kPa
 BP after ideling: 5,7 kPa (20,0 kPa)
 BP at maximum load: 19,5 kPa (37,2 kPa)
 BP at end of test: 4,0 kPa (10,6 kPa)
 BP fresh filter: 3,9 kPa

Temperature after filter distinctive lower than before filter
 Maximum temperature after filter: 475°C (547°C)
 Maximum temperature before filter : 504°C (549°C)

Werte in Klammern sind Werte vor Reinigung.

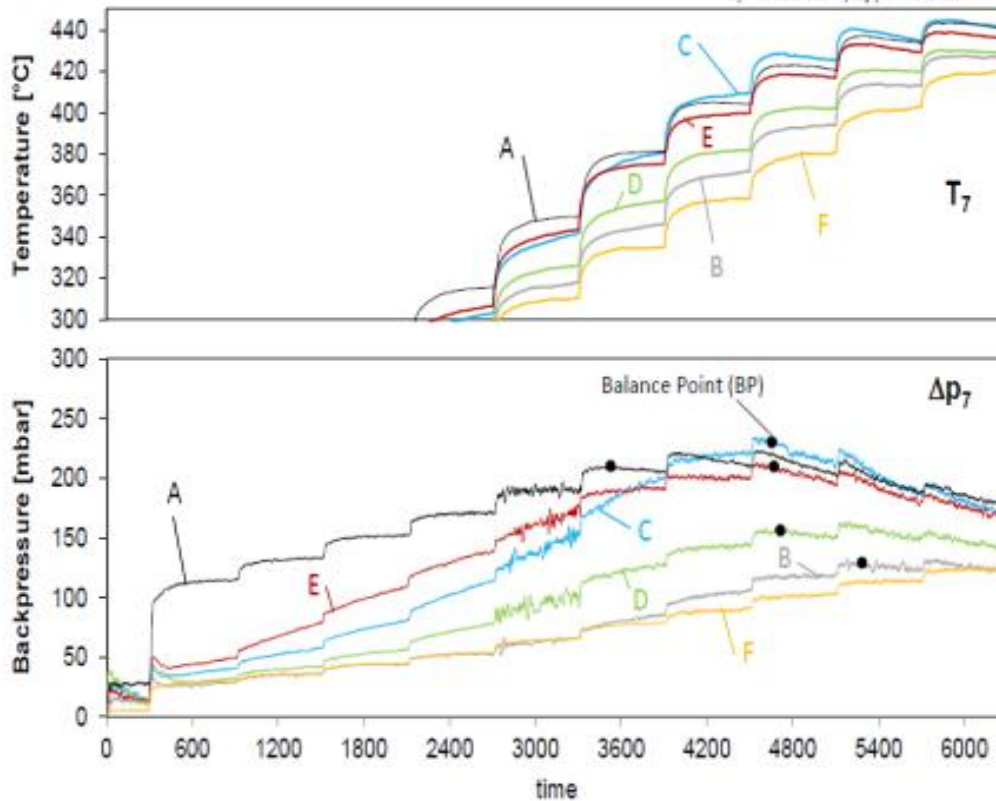
Comparison of temperature and backpressure during Reg Step, with TUNAP Cleaner

engine: Liebherr D934S A6; fuel: ulsd (S < 10 ppm) + Satacen 3 (40ppm)

T_7 : before DPF, Δp_7 : before DPF

- A-E: DPF loaded, regeneration
- A: without Cleaner Injection
- B/C: Cleaner Injection 1 side
- D/E: Cleaner Injection 2 sides
- F: DPF empty, no Cleaner

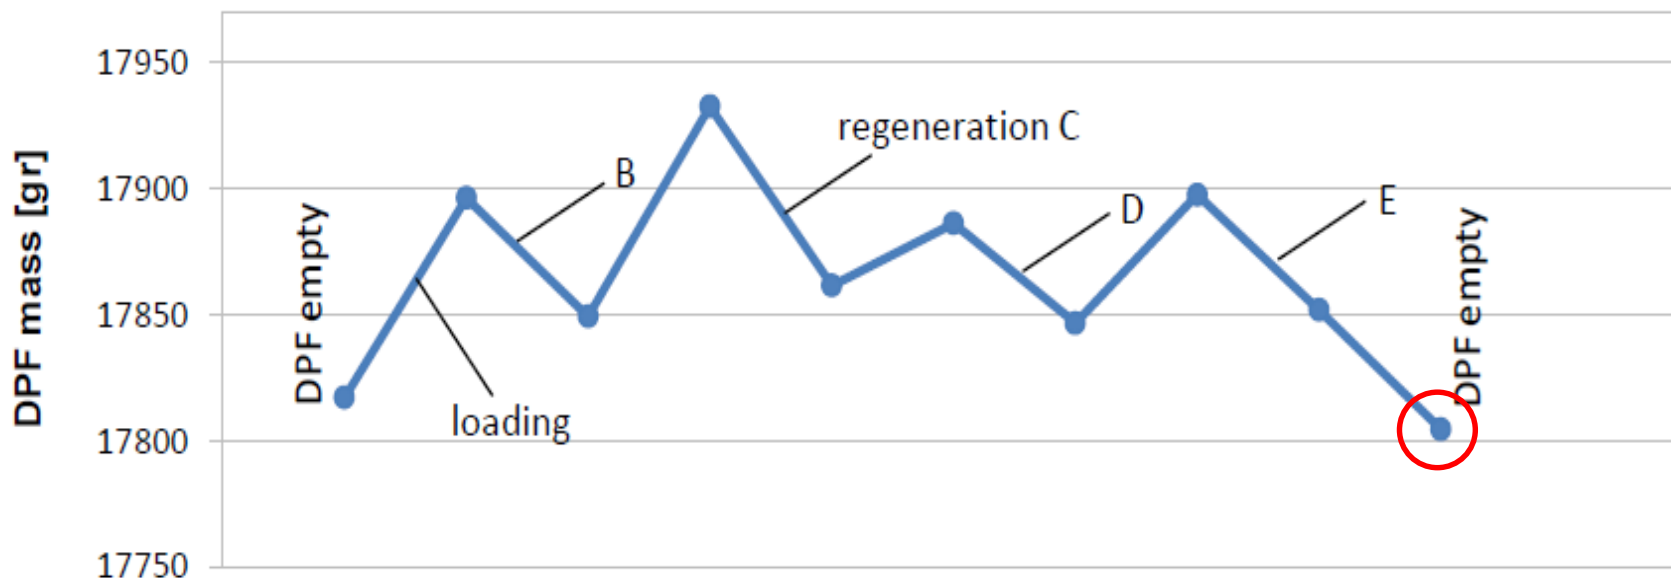
DPF mass evolution
during Soot Loadings and Reg Steps, with TUNAP Cleaner
engine: Liebherr D934S A6; fuel: ulsd (S < 10 ppm) + Satacen 3 (40ppm)

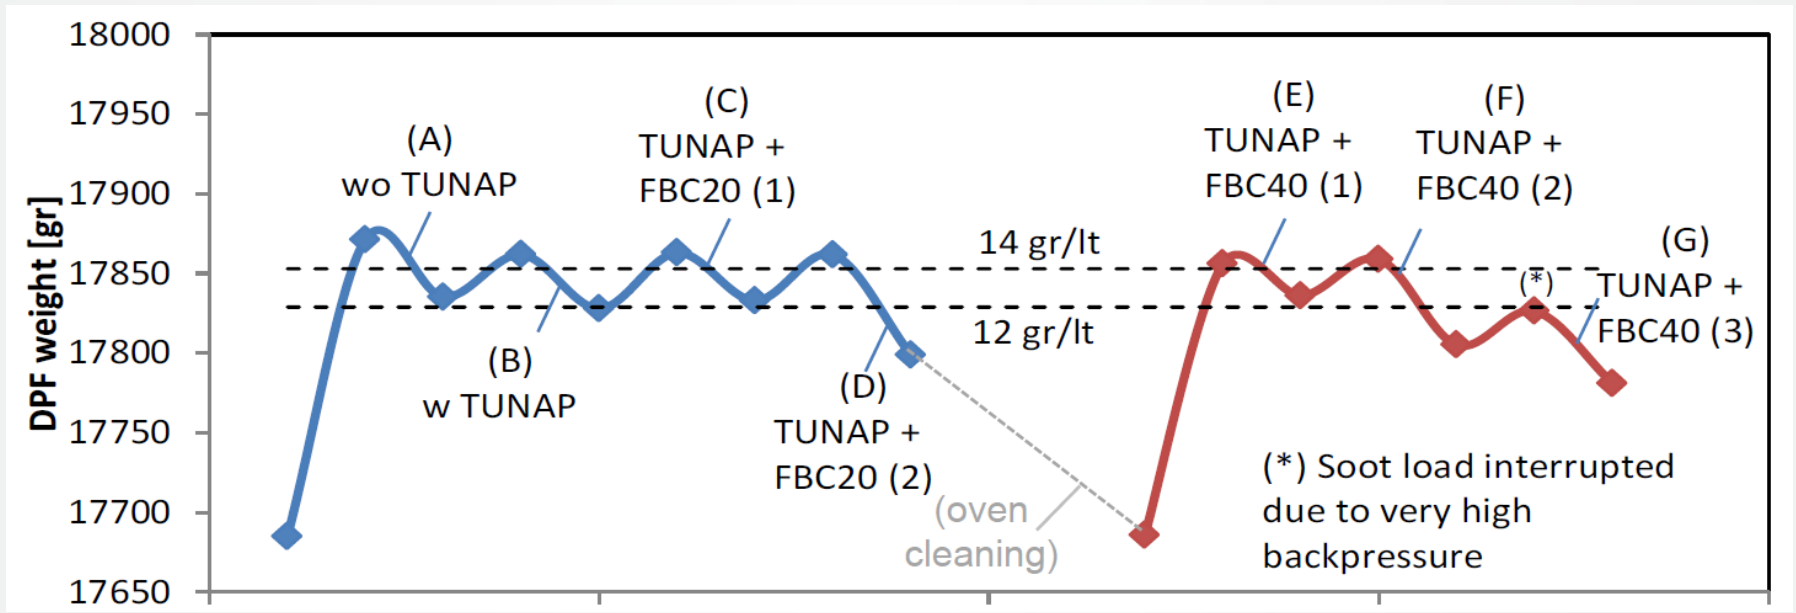
- A reduction in soot mass was found after using the cleaning method
- Addition of FBC showed positive effects
- Procedure was still not enough to accomplish a complete regeneration
